STEWART LAKE, DANE COUNTY 2006 WATER QUALITY MONITORING REPORT

Dane County Dept. of Land and Water Resources

October, 2006

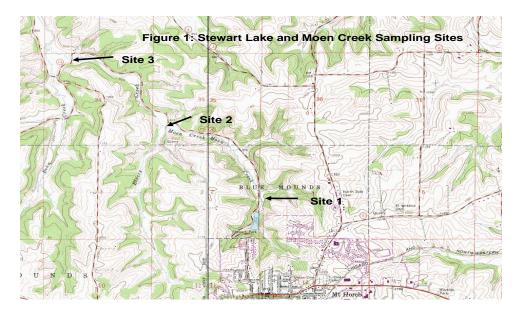
Below the dam, aquatic macroinvertebrates were collected from three locations (Figure 1) in Moen Creek during April 2006. Specimens were sorted and identified to the family-level. The Family-level Biotic Index (Hilsenhoff 1988) and Ephemeroptera-Plecoptera-Tricoptera families (EPTF) were calculated from each sample. A DC pulse backpack stream shocker was used to collect fish from Moen Creek in July 2006 and calculate the coldwater Index of Biotic Integrity (IBI – Lyons et al. 1996). Routine stream sampling included biweekly flow (G. O. Environmental mechanical flow meter), dissolved oxygen and temperature (YSI Model 52 meter). Long term summer water temperature data were collected at sites 1 and 2 with Onset Tidbit data loggers.

Macroinvertebrates were collected from Moen Creek on April 21, 2006 at three locations (Figure 1). Family-level Biotic Index (FBI) values ranged from 5.2 (Good) near the dam to 1.7 (Excellent) at site 2. The higher FBI value near the dam reflected high numbers of the freshwater sowbug (*Asellus intermedius*), however the most intolerant family of insects (Plecoptera) was also found near the dam and indicated good water quality. All three sites had healthy EPT representation as well (Figure 14).

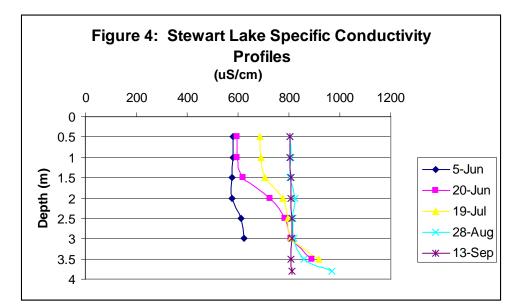
Conductivity and pH patterns (Fig. 3, 4) were typical for the observed dissolved oxygen levels and trends. Low dissolved oxygen, low pH and high conductivity reflected decomposition and biochemical oxygen demand below the surface while high pH and moderate conductivity occurred near the surface where photosynthesis exceeded decomposition. A trend of lower pH and higher conductivity values occurred as the summer progressed and reflected less primary productivity, greater respiration and release of nutrients in the water column. The trend of increasing specific conductance throughout the summer likely reflected decomposing rooted plants, primarily common waterweed. However, measurements exceeding 800 *u*S/cm are uncommonly high and apparently reflect high nutrients and minerals in the water column. On August 31 2006, levels in Stewart Lake (810 uS/cm) were significantly higher than levels found in Birch Lake (547 uS/cm), an eleven acre eutrophic impoundment located in Iowa County.

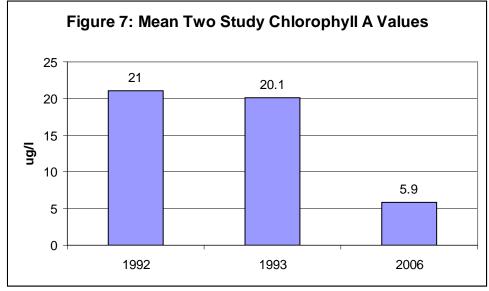
Water clarity was generally lower in 1992-93 (Figure 6), reflecting higher chlorophyll-a concentrations (Figure 7) linked to algal growths. The two study periods reflected extremes in lake conditions, algae dominated in the early 1990's and aquatic plants dominated in 2006. TSI values were not useful for comparing dramatic shifting plant communities, however both conditions reflected a nutrient rich eutrophic lake. The favorable Secchi TSI values certainly didn't indicate oligotrophic conditions in 2006, but rather reflected excessive aquatic plants and apparent suppression of algae. As the macrophytes died, phytoplankton did not increase significantly (based on clear water and low chlorophyll-a) and the lack of photosynthesis resulted in low dissolved oxygen levels. Mean phosphorus concentrations at the surface appear in Figure 6. Highest phosphorus concentrations occurred in 1992, however none of the phosphorus trends were consistent with the other TSI parameters (Secchi and chlorophyll-a).

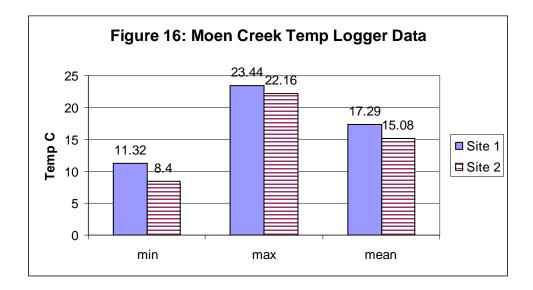
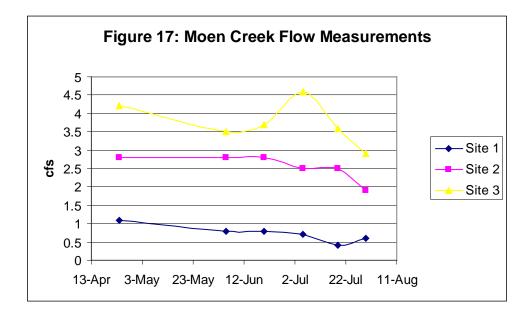
Biweekly stream flow and temperature monitoring indicated that the stream receives considerable groundwater discharge below the dam. Cold water temperatures just a short distance below the dam indicate that groundwater minimizes any thermal and water quality effects of the dam on Moen Creek (Figure 15, 16). Increased flow measurements below the dam reflect significant groundwater sources (Figure 17) and sustainable cold temperatures at Site 2 (Figure 15, 16). All instantaneous dissolved oxygen measurements were above minimum water quality criteria.

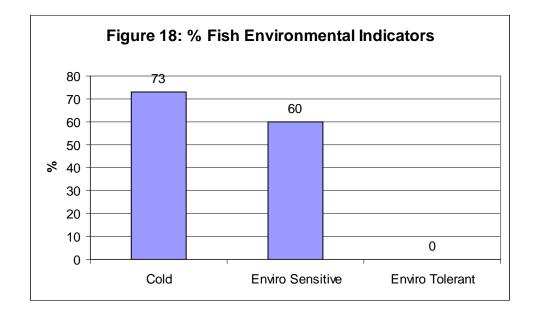
A stream shocking survey was performed on July 27, 2006 using a battery powered backpack stream shocker. The small stream was choked with dense overhanging reed canary grass, undermining effective sampling. Regardless, fish species collected were typical of high quality cold water streams, with mottled sculpin (*Cottus bairdii*) dominant and juvenile brown trout (*Salmo trutta*) also common. Eurythermal fantail darters (*Etheostoma flabellare*) were relatively abundant at site 3 but no environmental tolerant species were found. Figure 18 represents the composite fish community data from sites 1-3.

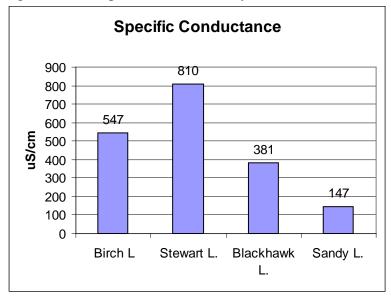
Figure 19: Comparative Conductivity Measurements

Birch Lake: 11 acre eutrophic impoundment in Iowa County Blackhawk Lake: 220 acre mesotrophic impoundment in Iowa County Sandy Lake: 9 acre softwater seepage lake in Marquette County
