Survey of Rice Lake
Dane County, Wisconsin

Small-scale Lakes Planning Grant Project

November 2011

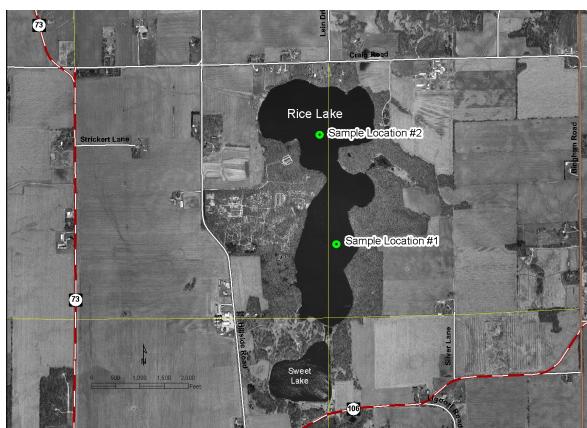
Figure 3. Sampling locations on Rice Lake

Lake profile and biological sampling surveys were performed on June 30th and August 1, 2011. Lake profile sampling was conducted at Site 1 in the south basin (42 degrees, 53.719 min. – 89 degrees, 01.935 min.) and Site 2 in the north bay (42 degrees, 54.098 min. – 89 degrees, 02.01 min.). See Figure: 3

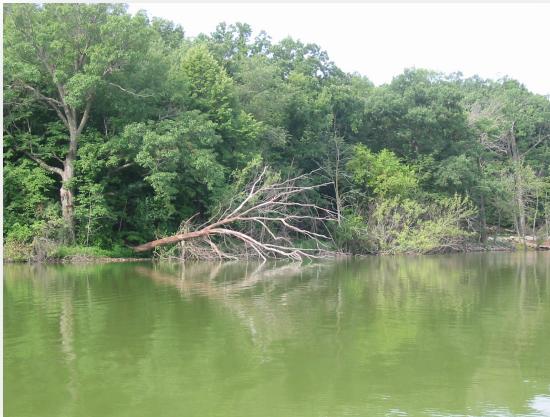
Figure 4: Algal Bloom

Survey results indicated that the lake is hypereutrophic with water clouding Cyanobacteria blooms. See Figure 4. Secchi measurements ranged from 2-3'. Very high pH was measured in the lake and likely reflected photosynthesis of algal blooms with chlorophyll-a concentrations up to 55 ug/l. Even though the lake is shallow and subject to mixing, anoxia was measured just below 1 meter below the surface.

7. Water quality data indicates highly eutrophic conditions. With internal cycling of phosphorus suspected, an analysis of the sediment nutrient conditions should be performed.

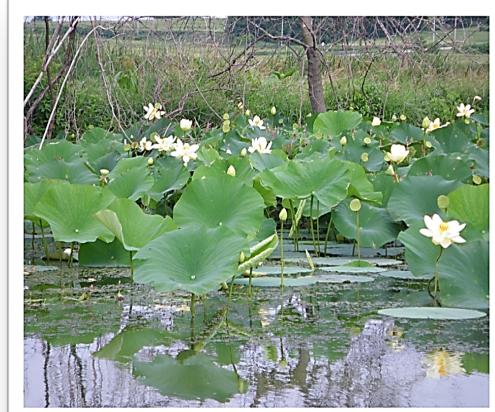
Figure 5: American lotus

Despite the poor water clarity, rooted aquatic plants were observed in modest densities including curly-leaf pondweed, small pondweed, Sago pondweed an Elodea. A substantive American lotus bed was observed in the north bay. See Figure 5.

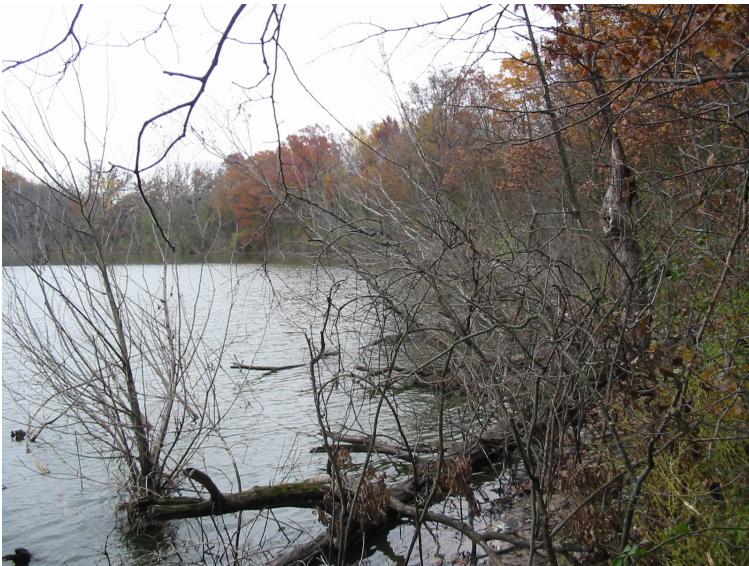
Fish populations were relatively scarce nearshore but may have reflected unusual distribution due to shallow anoxia as mentioned above. Seining and electroshocking revealed modest numbers largemouth bass, crappies, bluegill and immature golden shiners. An angler at the campground reported catching yellow perch, crappies, largemouth bass, bluegill, black bullhead, northern pike and rock bass. She also commented her concern over frequent algal blooms. In 2006, a WDNR boom shocking survey revealed 2 northern pike, 164 bluegill, 6 yellow perch, 14 crappies, 15 black bullhead, 4 golden shiners and 1 green sunfish. No endangered or threatened species were observed but numerous snags around the lake offer favorable turtle basking habitat. See Figure 6.

Figure 6: Favorable woody debris is scattered along the shoreline of Rice Lake. Areas provide critical cover for juvenile fish and habitat for nongame species.
