Impacts of Water Levels on Upper Yahara River Wetlands

Russ Hefty
Conservation Resource Supervisor
City of Madison Parks Division
(608) 267-4918

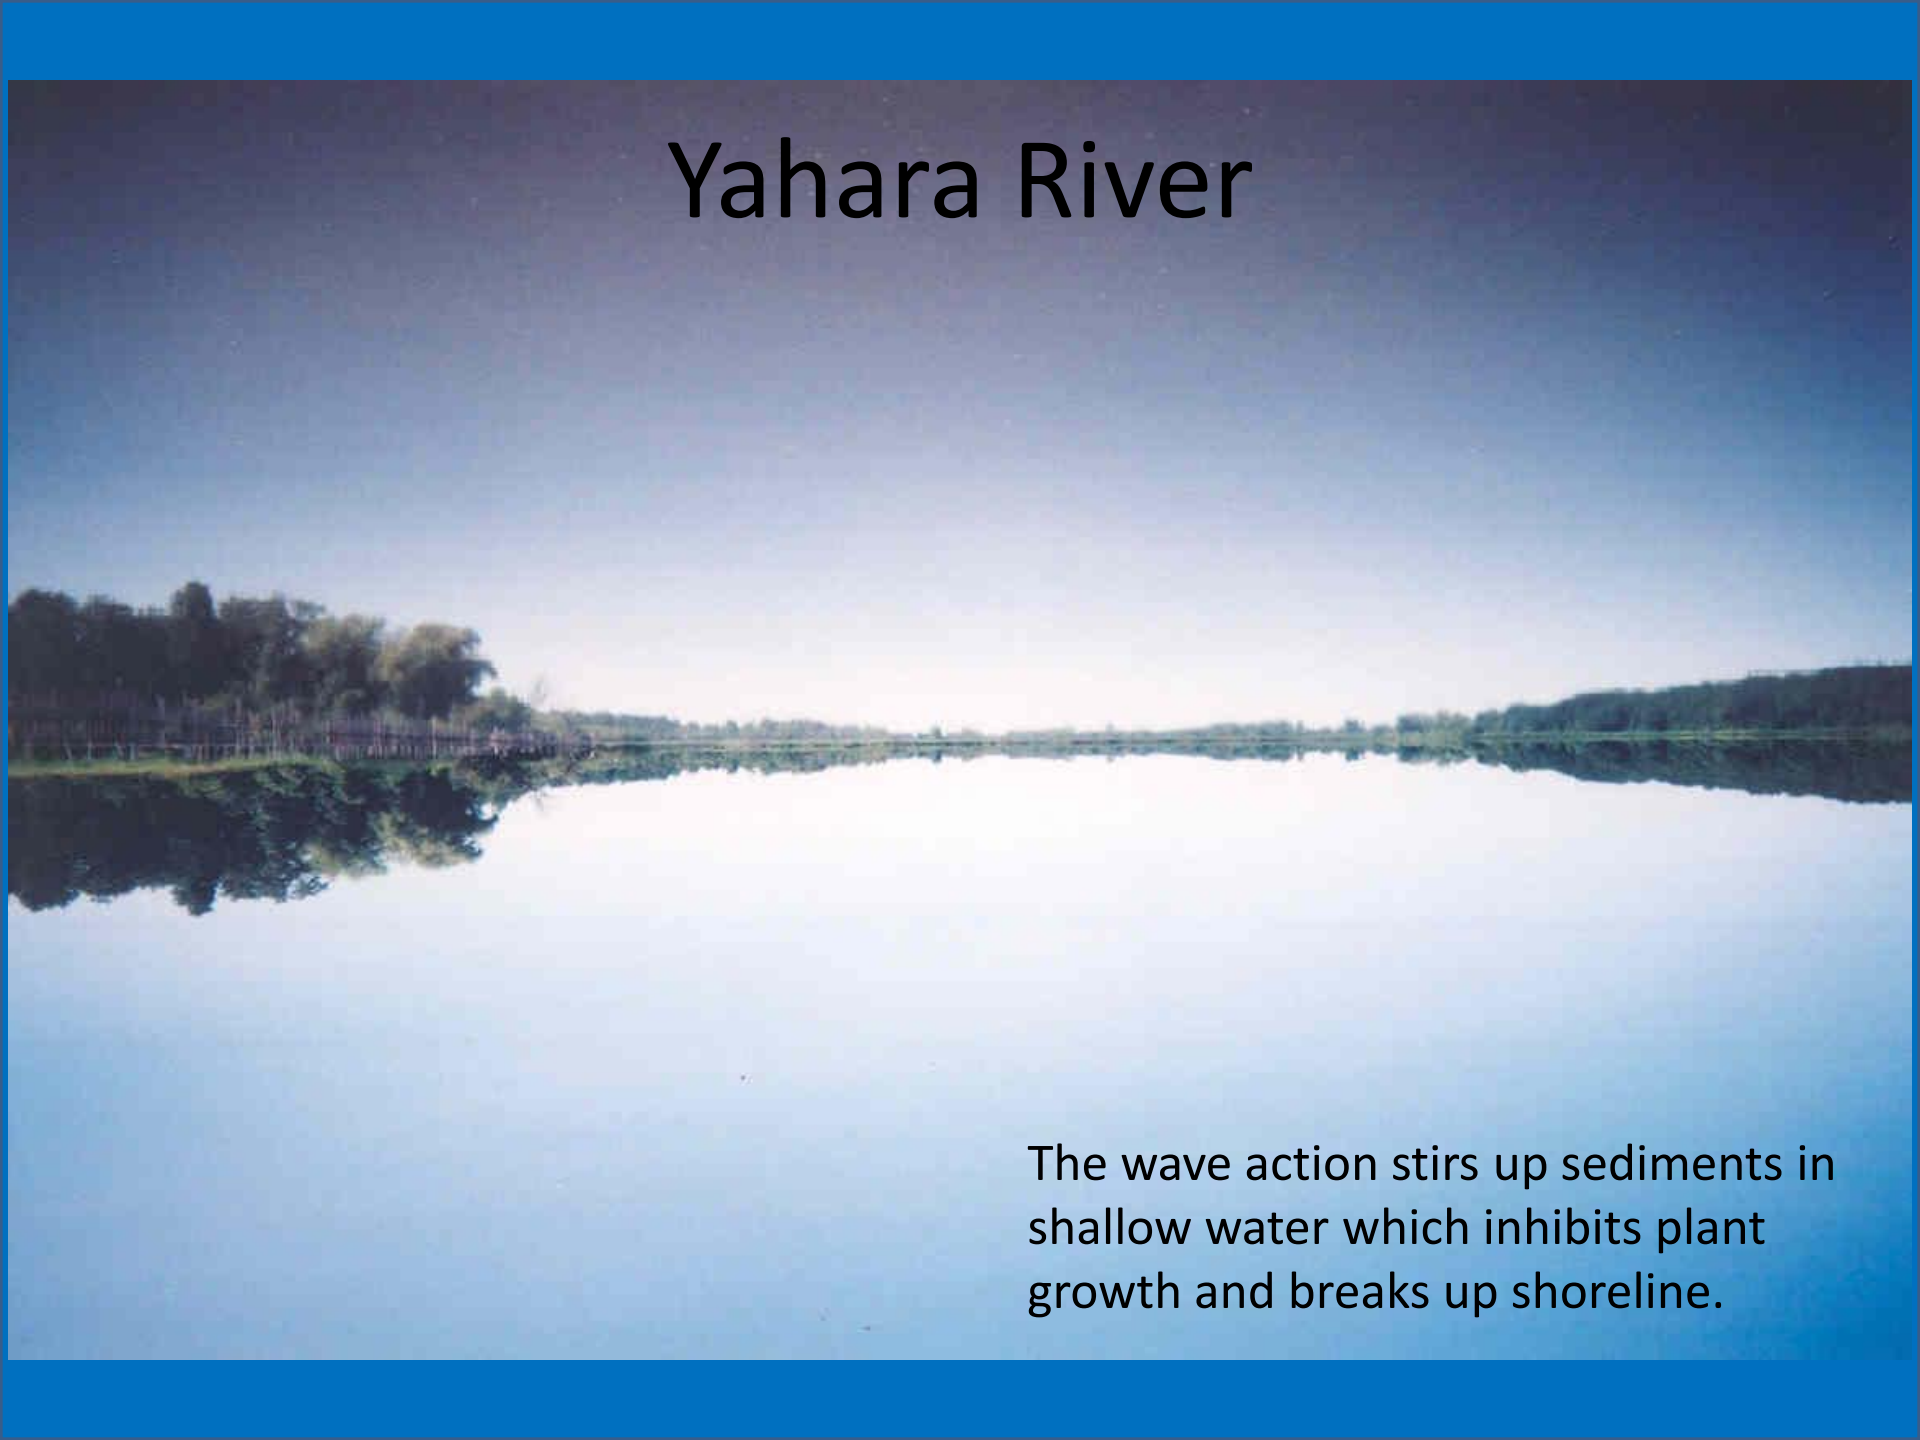
Yahara River

The wave action stirs up sediments in shallow water which inhibits plant growth and breaks up shoreline.

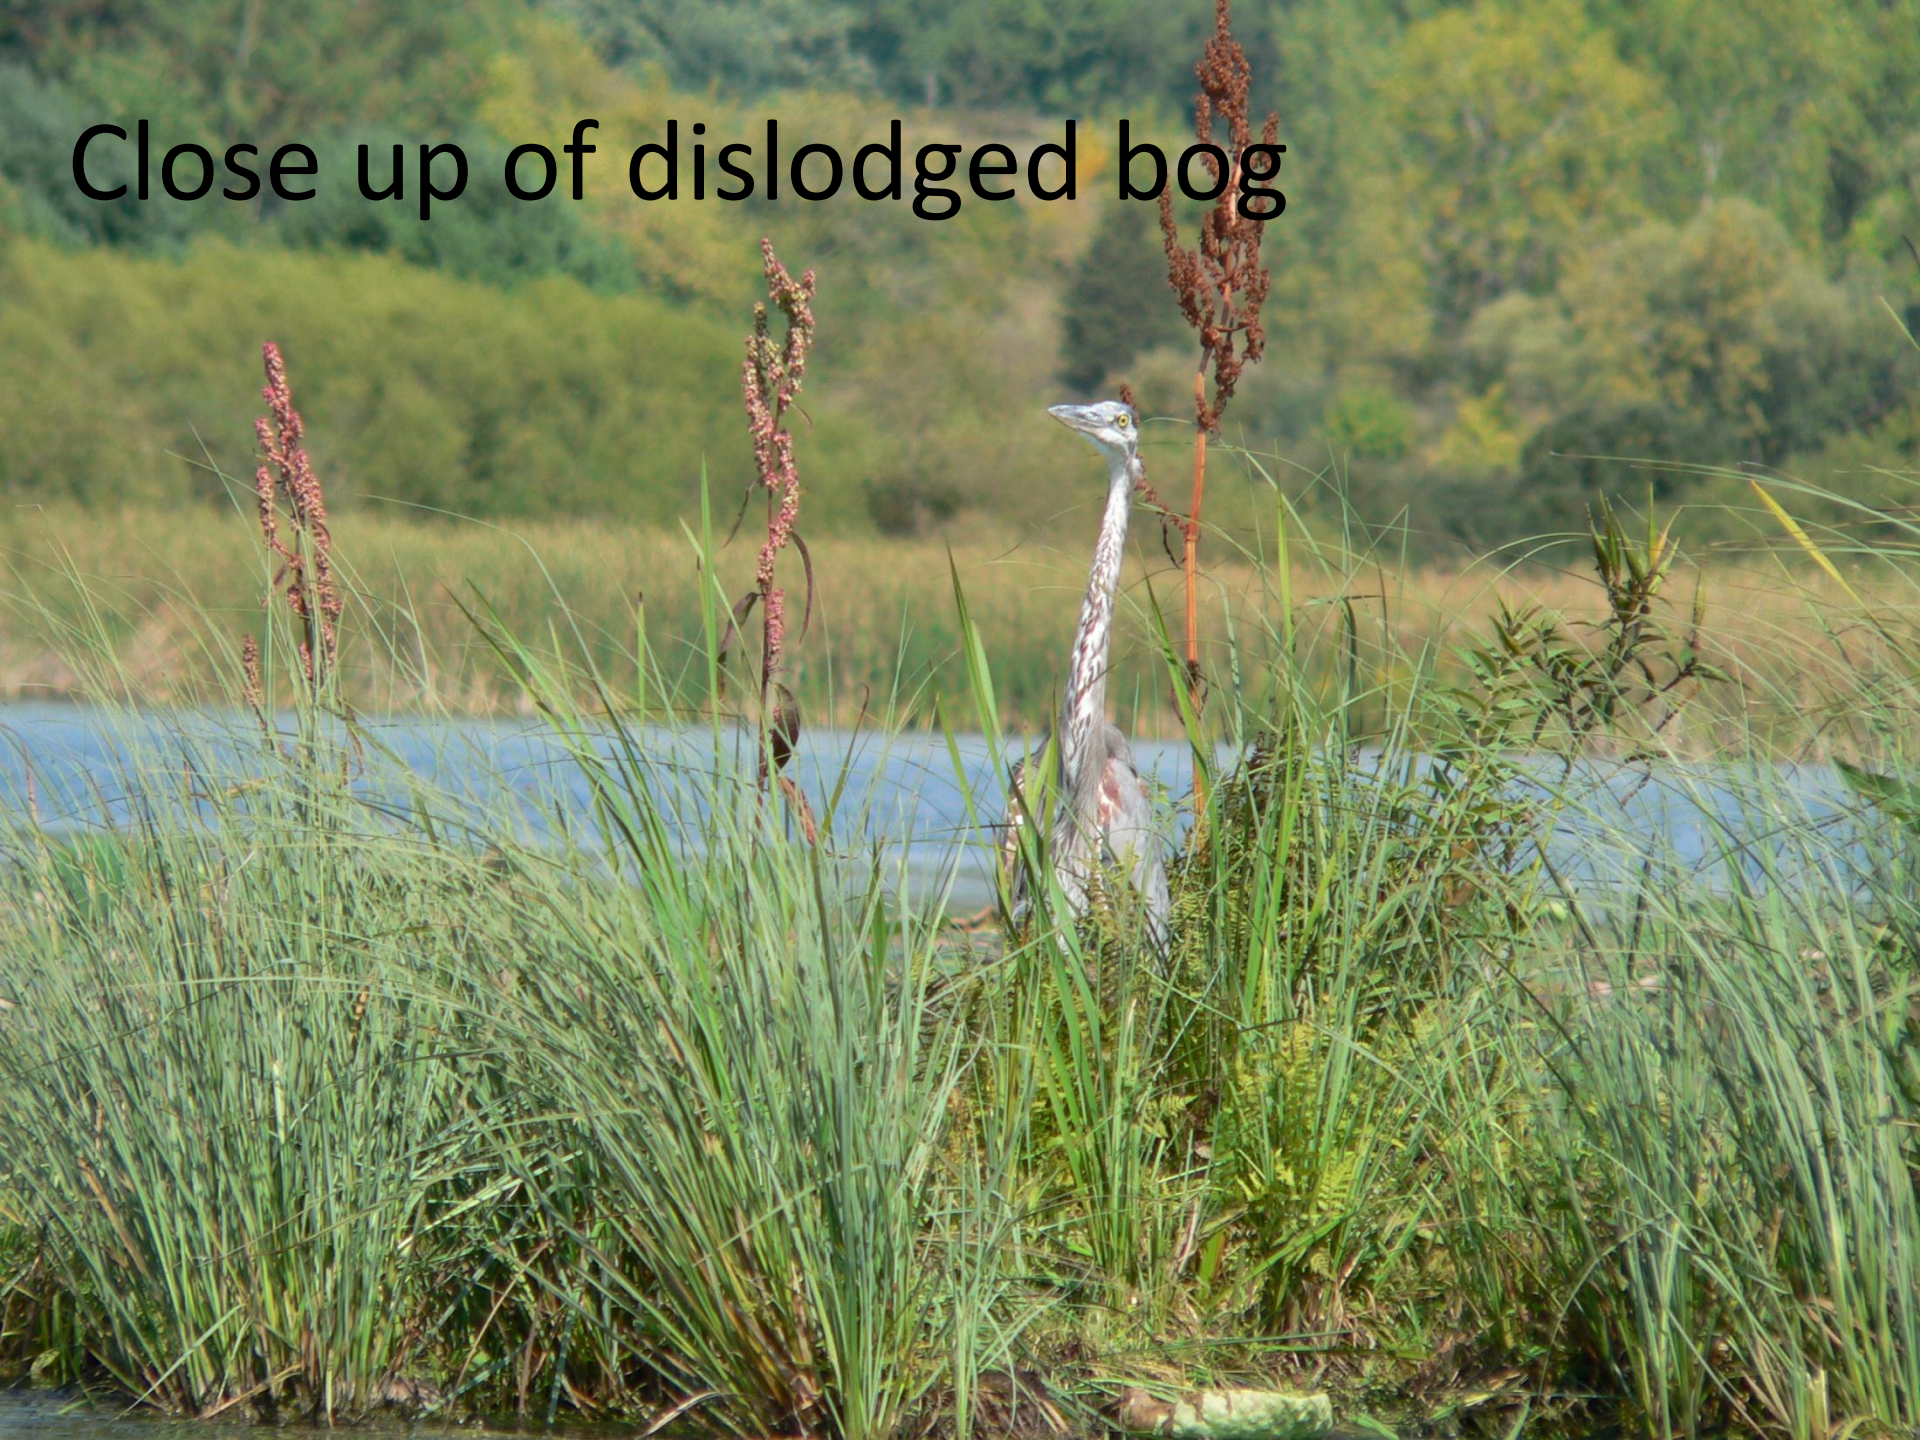
Close up of dislodged bog

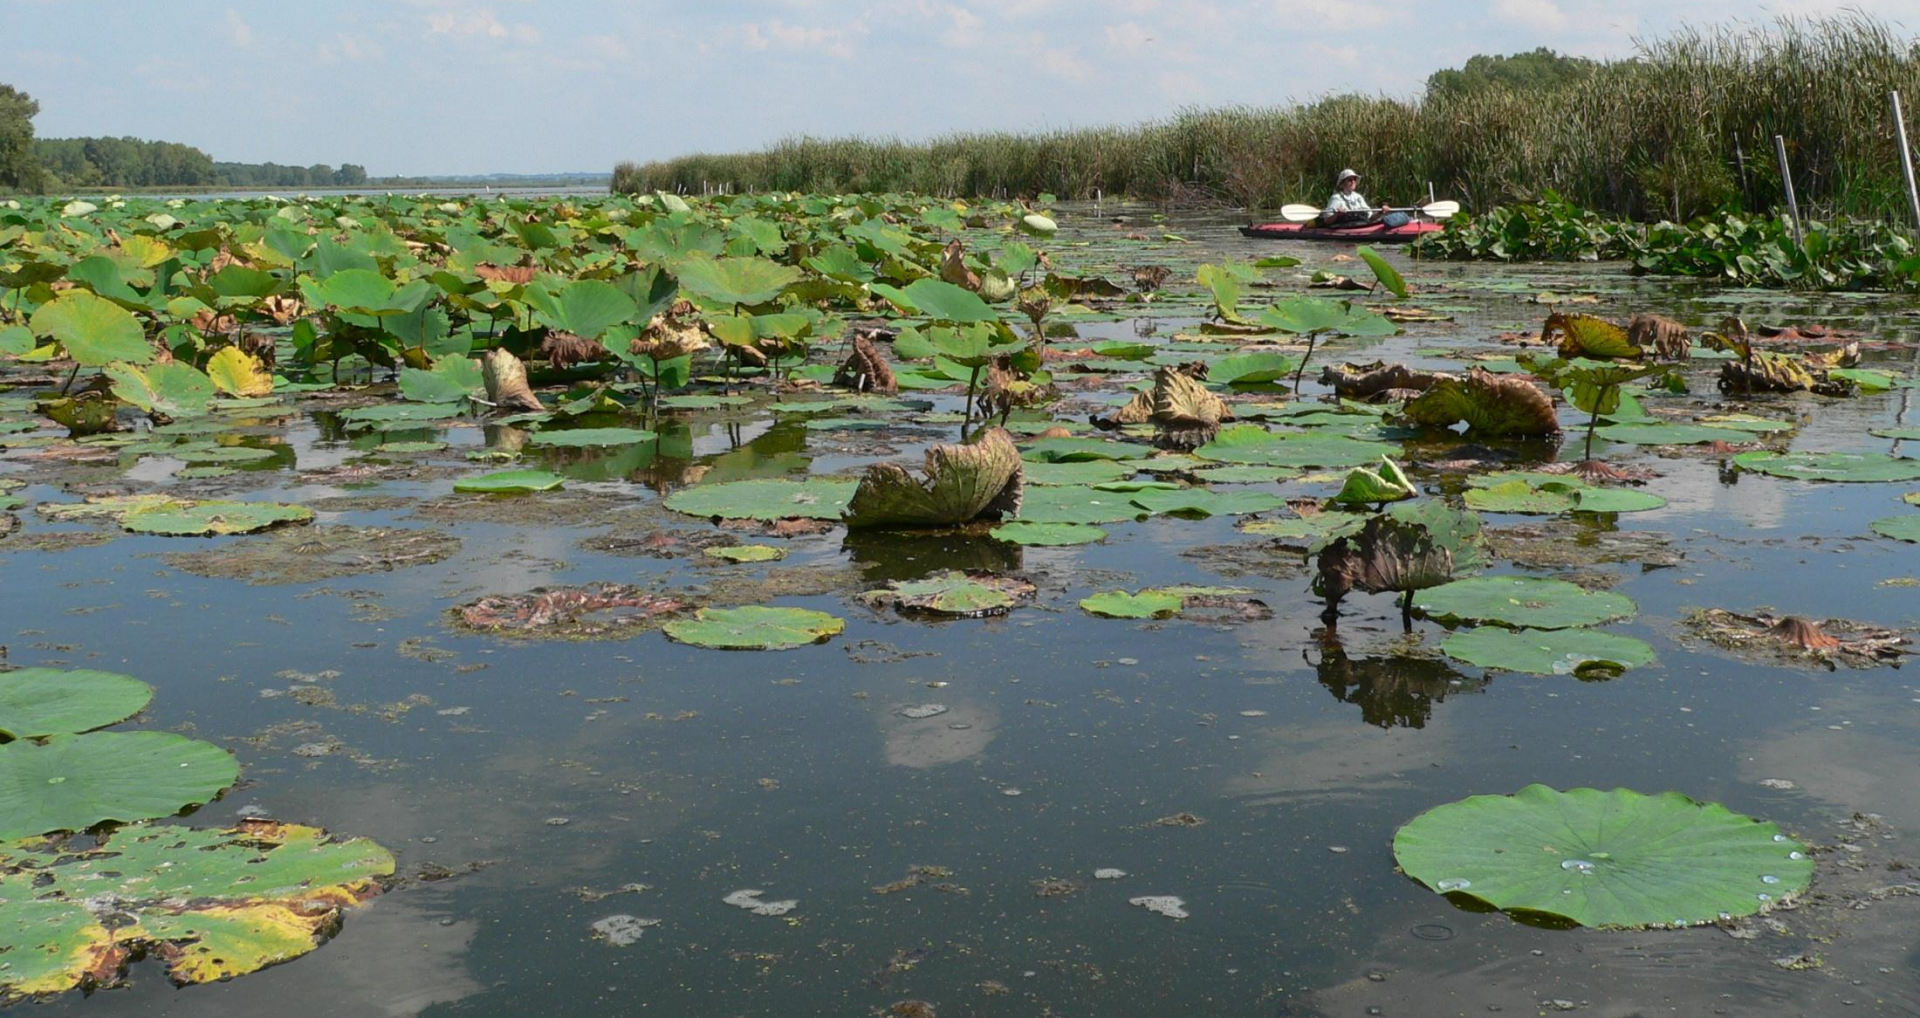
Buffering floating shorelines with aquatic plants

- Aquatic plant buffers have the potential to stabilize 'floating bog' shorelines.
- Aquatic plant communities trap sediment.
- A decrease in summer water levels would benefit emergent plant growth in the river bed.

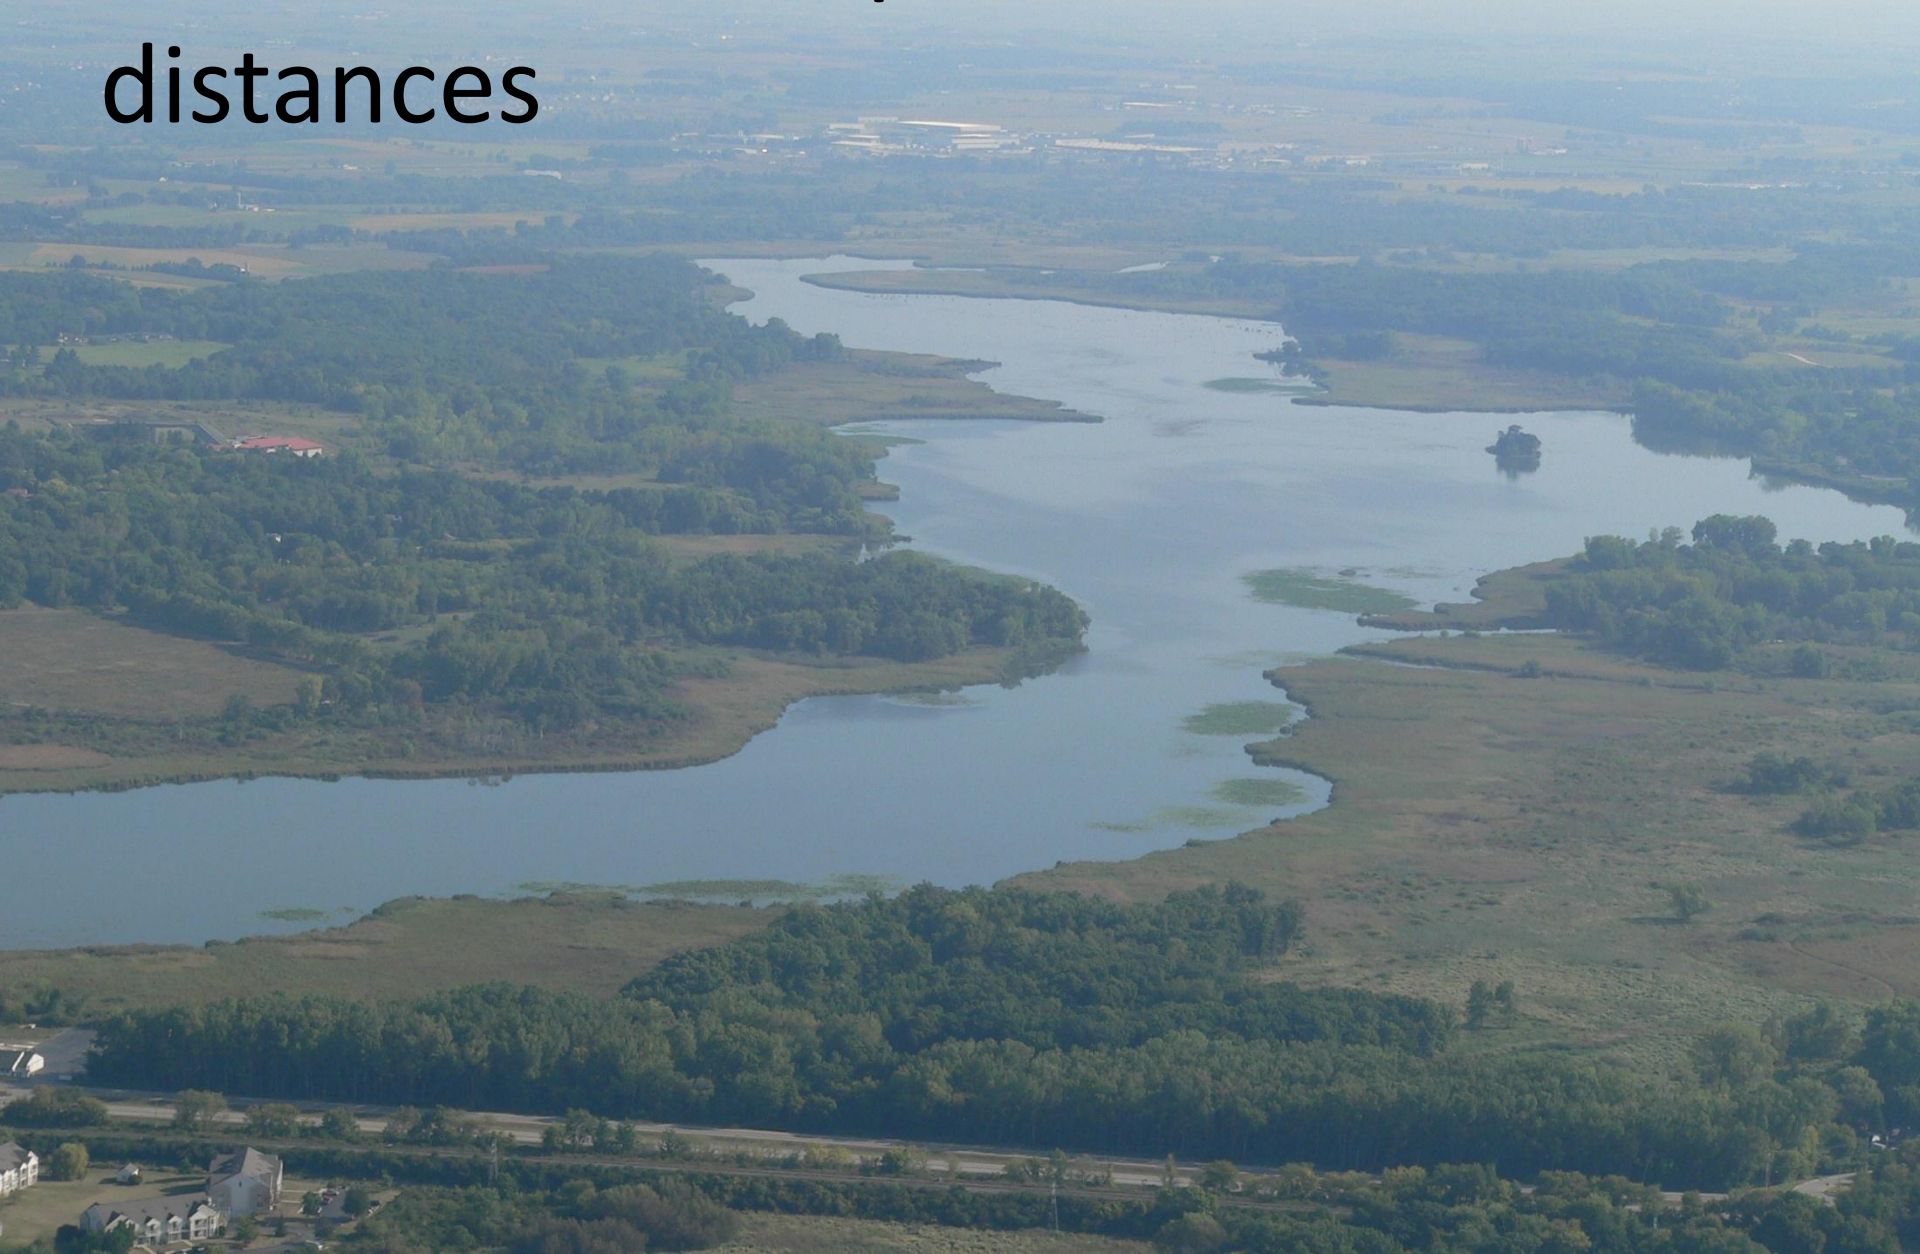
American Lotus plants reduce fetch distances

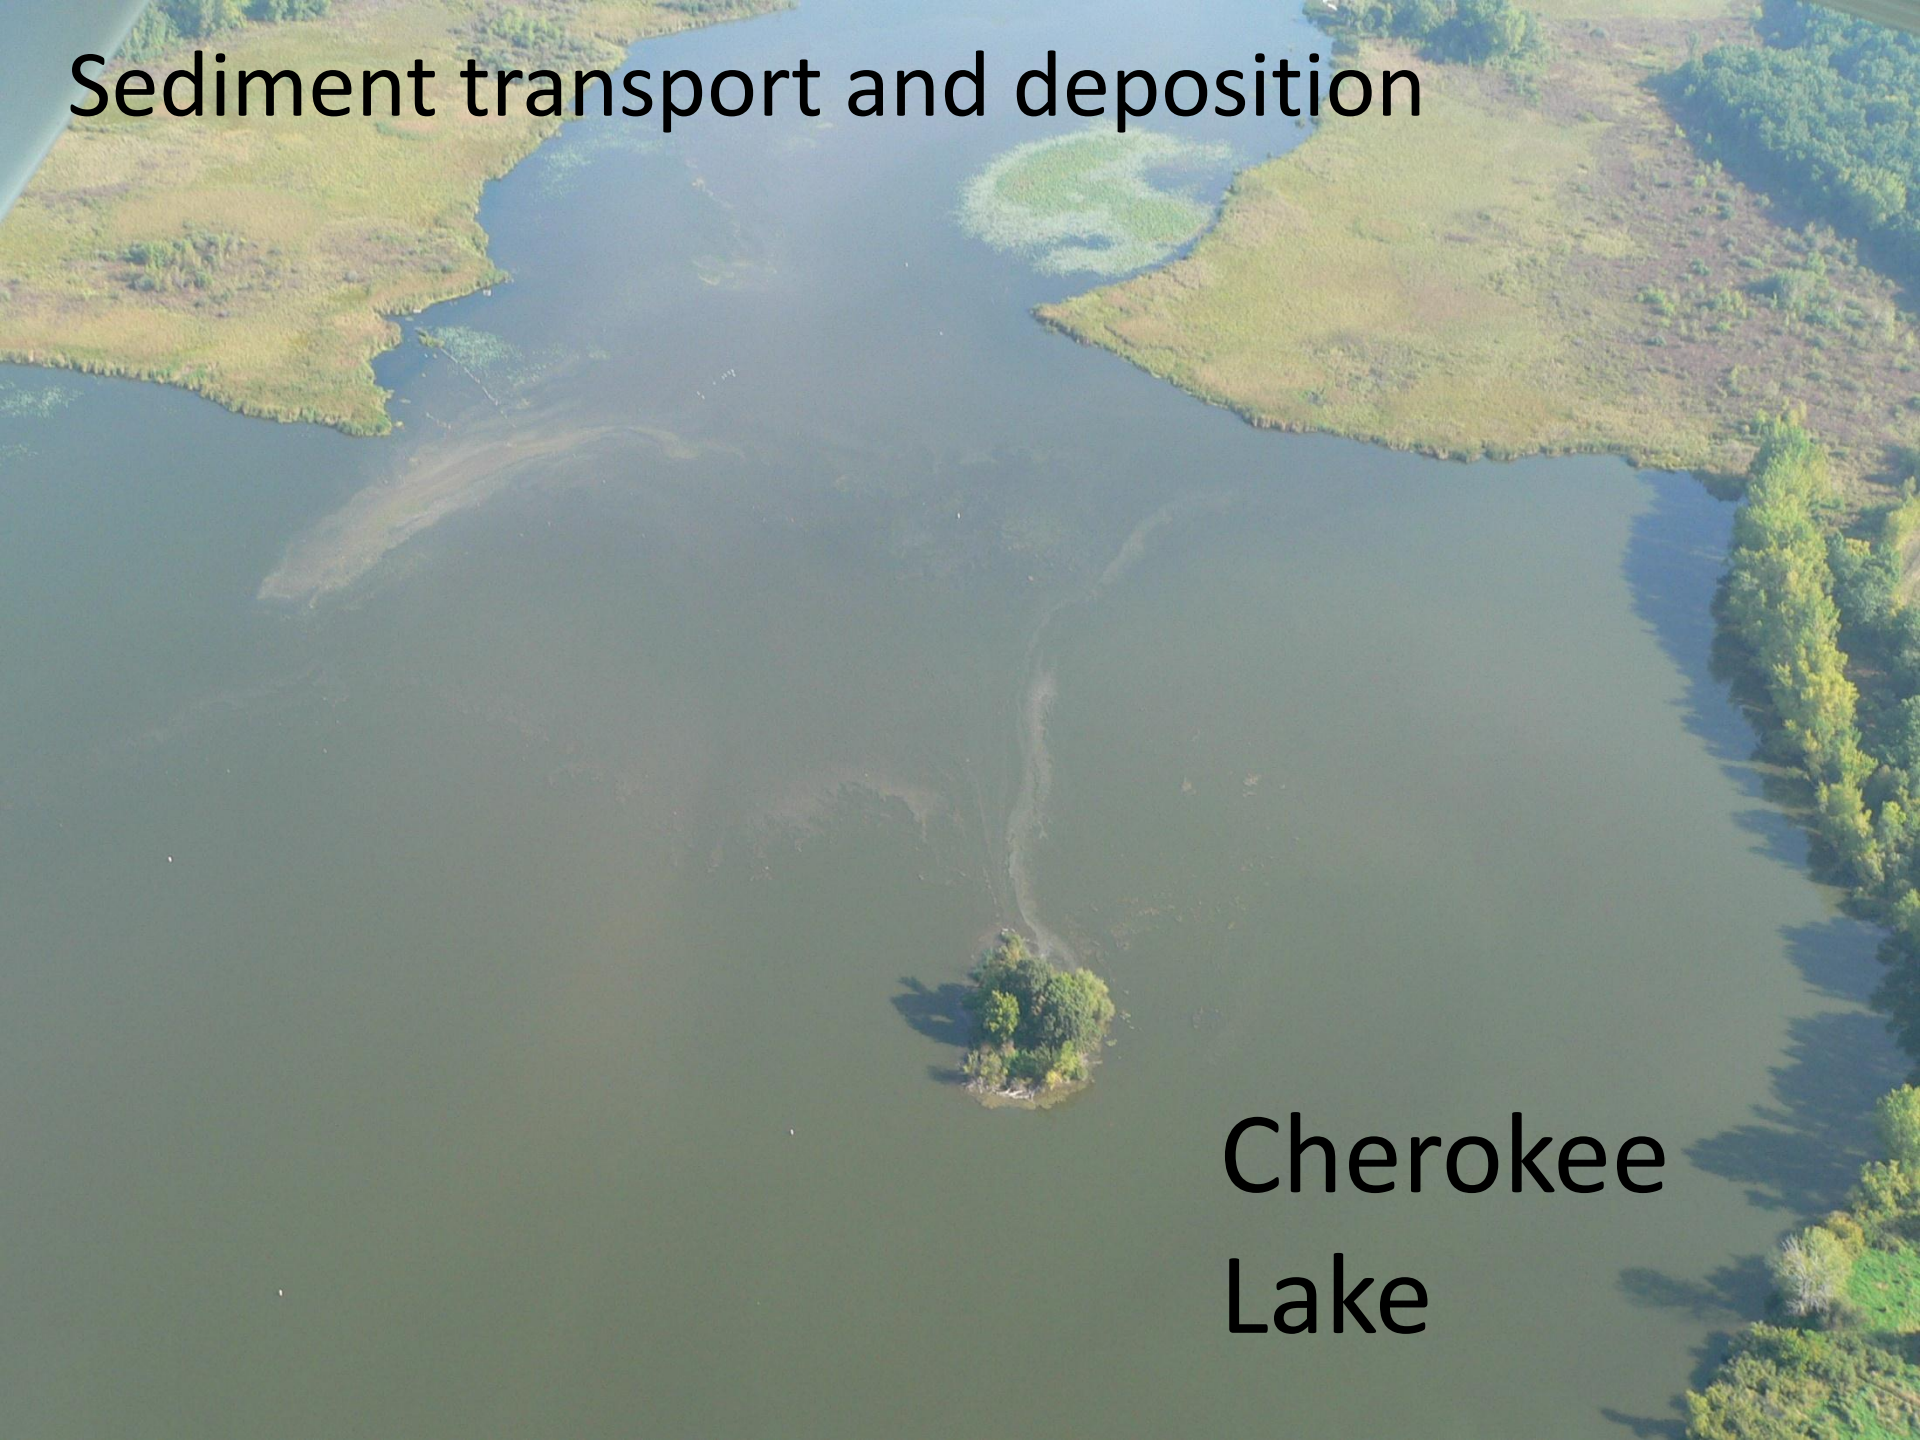
Sediment transport and deposition
