# Annual Dane County Yahara WINS Adaptive Management Report

Annual report on Dane County Land & Water Resources Department efforts assisting with the implementation of conservation practices that reduce phosphorus runoff for the Yahara WINS Adaptive Management project.

**2023 Report Year**

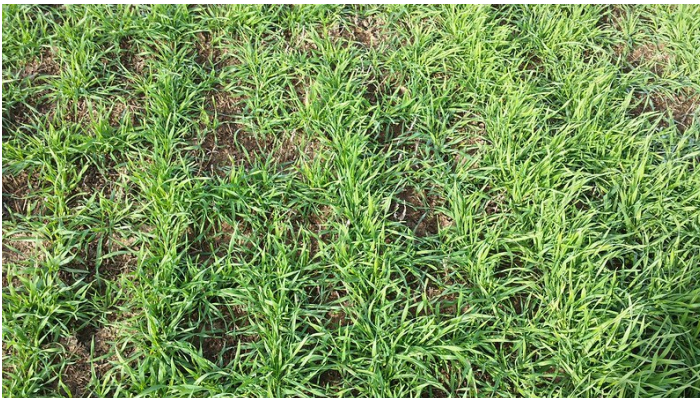
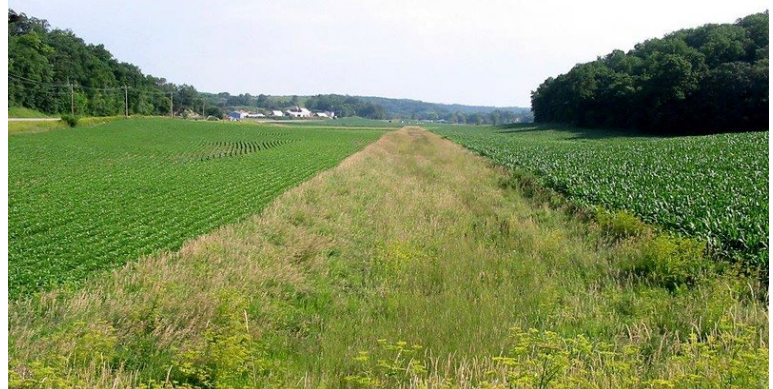
Left: Cover Crops Right: Grassed waterway

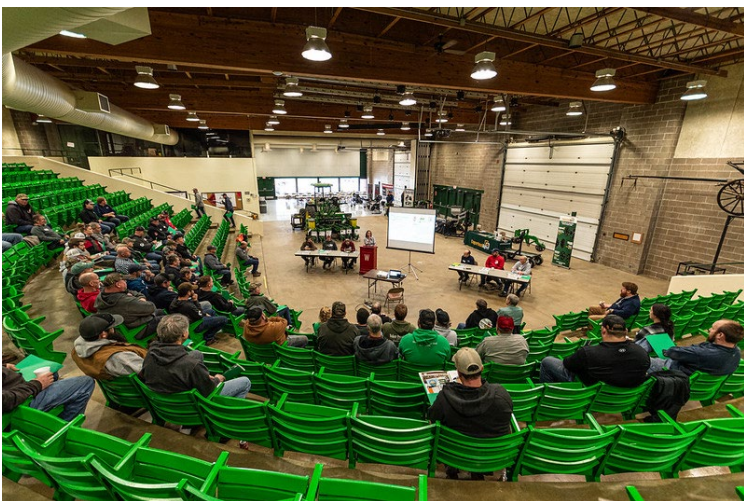
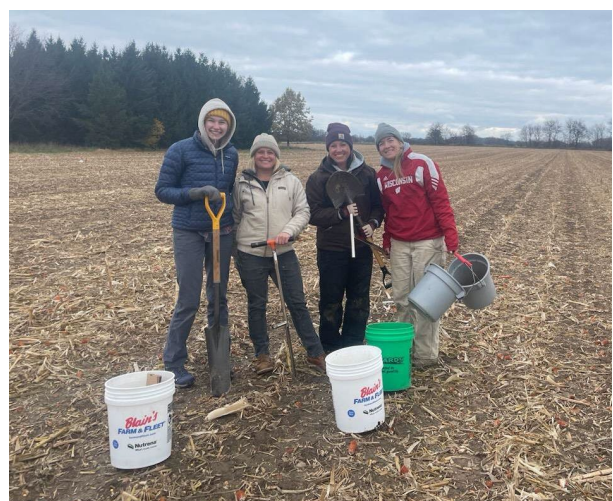
Left: A Planter Clinic hosted at UW Arlington Agriculture Research Station; Right: County staff collecting soil samples as a part of on-farm research

Additionally, Dane Demo Farms will conduct on-farm research in partnership with UW-Madison. Research is focused on conservation practices that help protect local water quality and build soil health, with research projects that are designed to answer specific questions farmers have regarding crop management and economics. A number of the participating farms will also have edge-of-field monitoring stations installed to help quantify the real world surface water quality impacts of the tested conservation practices. More information is available on-line at

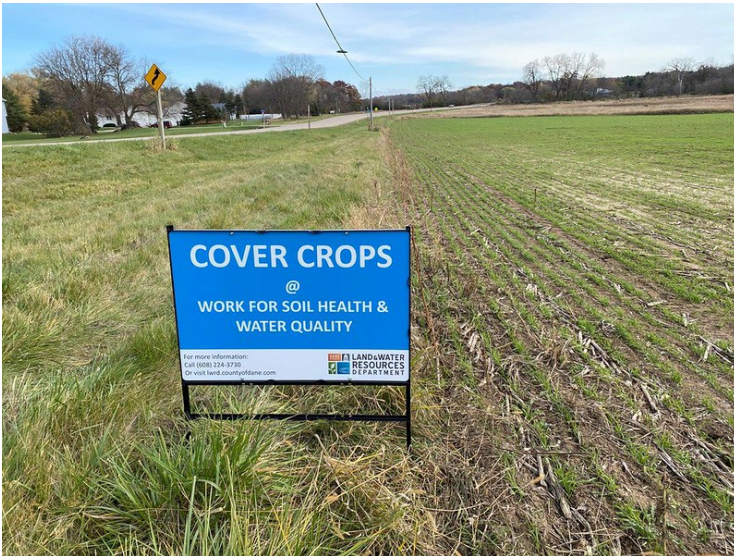
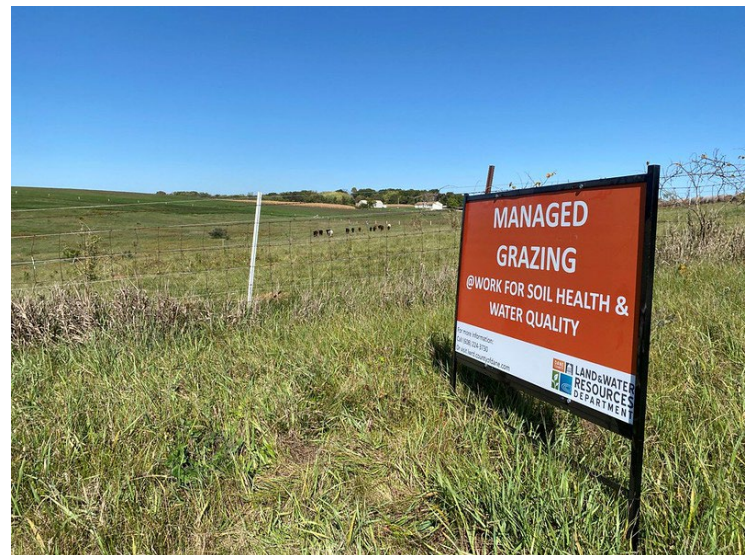
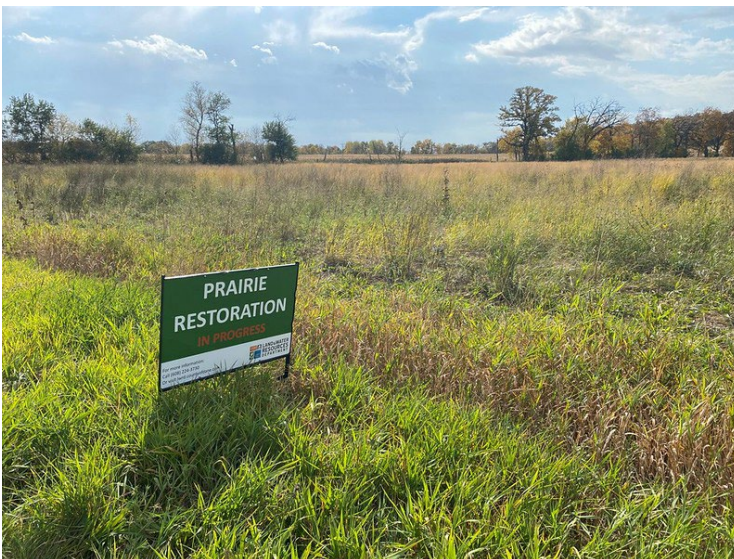
Above: Conservation signs placed throughout Dane County to showcase conservation practices

In addition to Dane Demo Farms, county staff have increased awareness about conservation practices by developing signs for landowners to display for grazing, cover crops, and prairie restoration. While seeing conservation actively on the ground, other landowners can easily contact county staff to implement these practices.

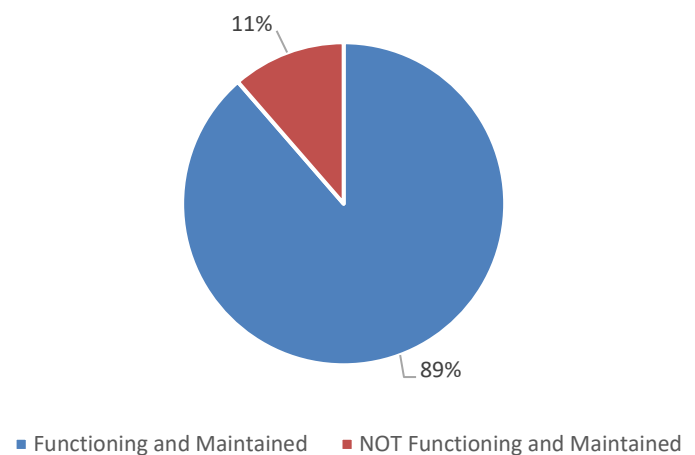
**FIGURE 4.**

Field verification and review of conservation practices.

Of the 167 conservation practices that were identified for verification this past year, Dane County staff inspected all of them. All inspected practices were located in TMDL reaches 62, 63, 64, 66, and 67. Of those checked 167 (89%) were found to be functioning and maintained while 19 (11%) were not (Figure 4.). Reasons for these practices no longer functioning and being maintained include conversion of land use from agriculture to residential or practices requiring repairs and maintenance.

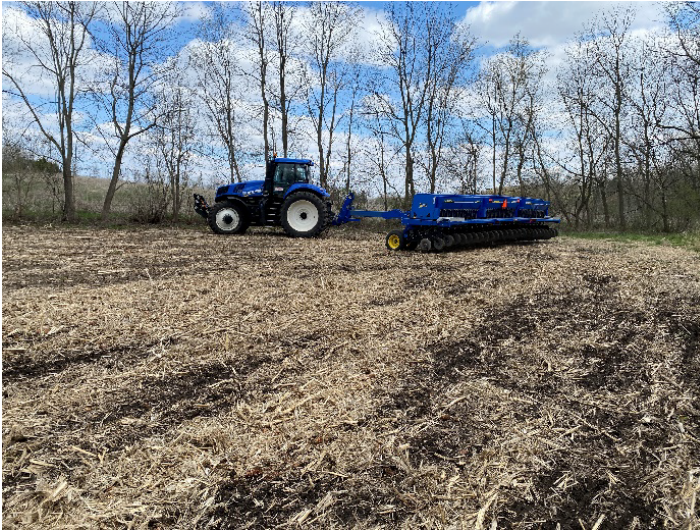
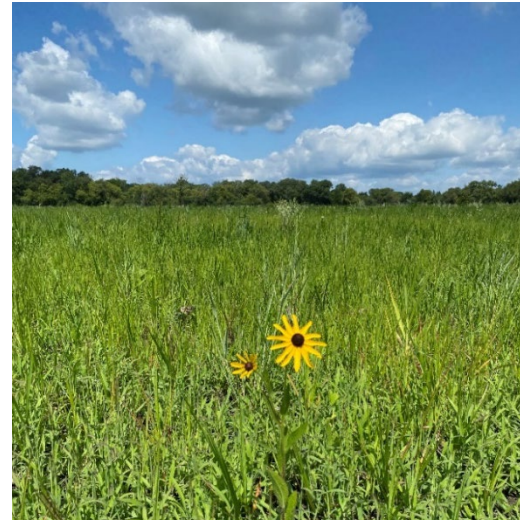
Left: CCP Field being no-till planted to pasture Right: Newly established prairie

Dane County's Continuous Cover Program, launched in 2019, continues to be a popular program. This program provides cost-share assistance to landowners for the establishment and maintenance of a continuous living cover on lands that are traditionally row-cropped. Landowners can convert row cropped fields to cool season grasses, prairie and pollinator habitat, or forage for managed grazing. The option to incorporate trees into plantings, such as agroforestry or silviculture, was added to the program in 2023. More information on the program can be found here: <https://lwd-countyofdanecounty.com/Continuous-Cover-Program>

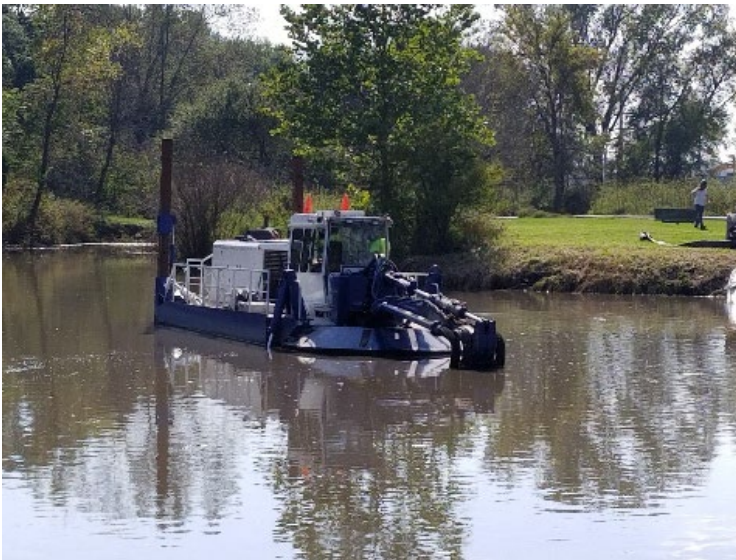
Hydraulic dredge removing legacy sediments from Token Creek.

Since 2016, Dane County has been assessing and removing legacy sediments within stream tributaries of the Yahara Watershed. Dorn Creek, Sixmile Creek, Token Creek, Door Creek, Nine Springs Creek, and the Yahara River have all been sampled and assessed for both phosphorus concentrations and sediment volumes. Sediments have been removed from three sites; Dorn, Sixmile and Token Creeks.

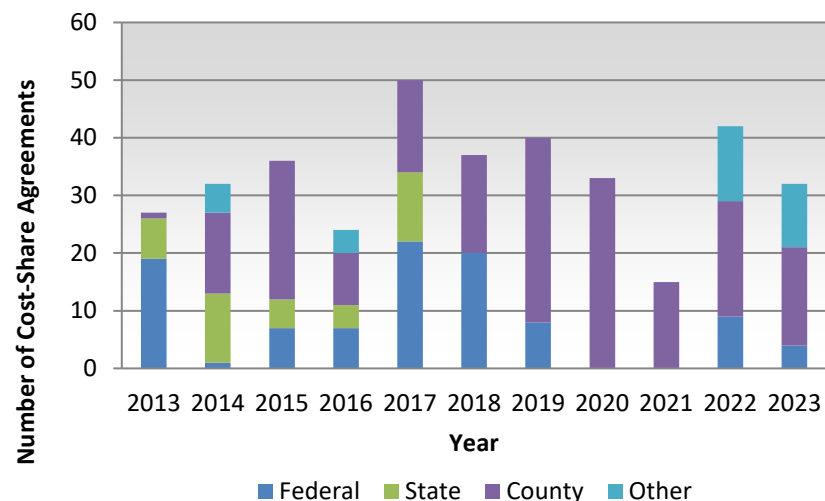
**FIGURE 6.**

Number of cost-share agreements annually by funding source within the Yahara watershed since 2013.

Dane County assisted with obligating 32 new cost-share agreements with landowners, utilizing federal, county and other funding sources (Figure 6.) within the Yahara. Total cost-share funding for the 32 agreements was over \$600,000 (Figure 7.). Since 2013, Dane County has assisted with cost-share agreements totaling over \$7 million for conservation practices that reduce phosphorus within the watershed. Dane County strives to utilize and leverage all funding sources available to landowners and producers including federal, county, and other sources (i.e. Yahara WINS, Clean Lakes Alliance grants, etc.). Available funds and conditions vary based on the source of funds. Similarly, the number of cost-share agreements executed annually varies, often limited by available annual funding and interest from landowners and producers.

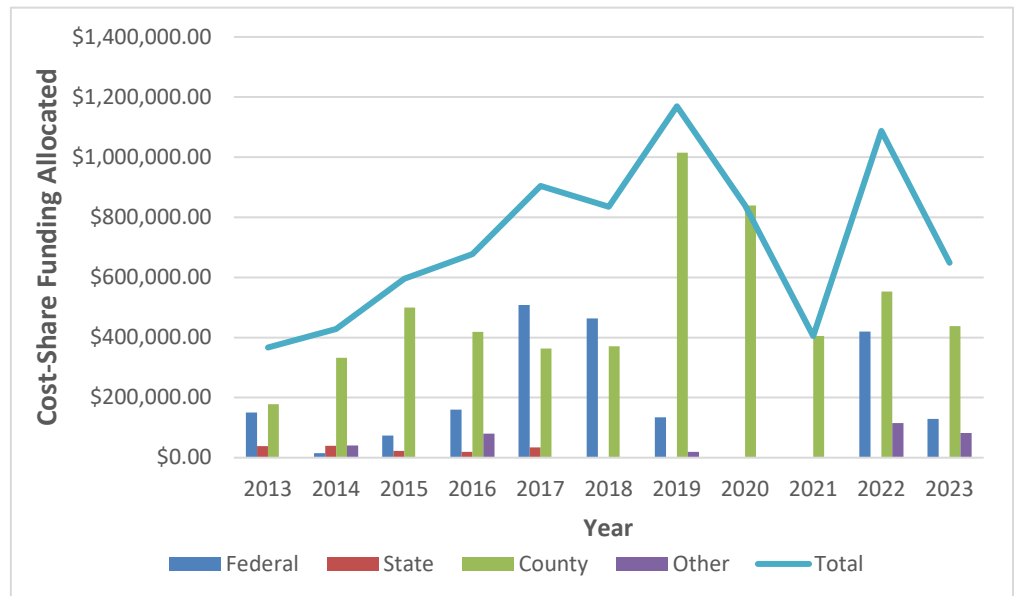
**FIGURE 7.**

Total cost-share dollars allocated by funding source annually within the Yahara watershed since 2013. The cumulative total from all funding sources is also presented.

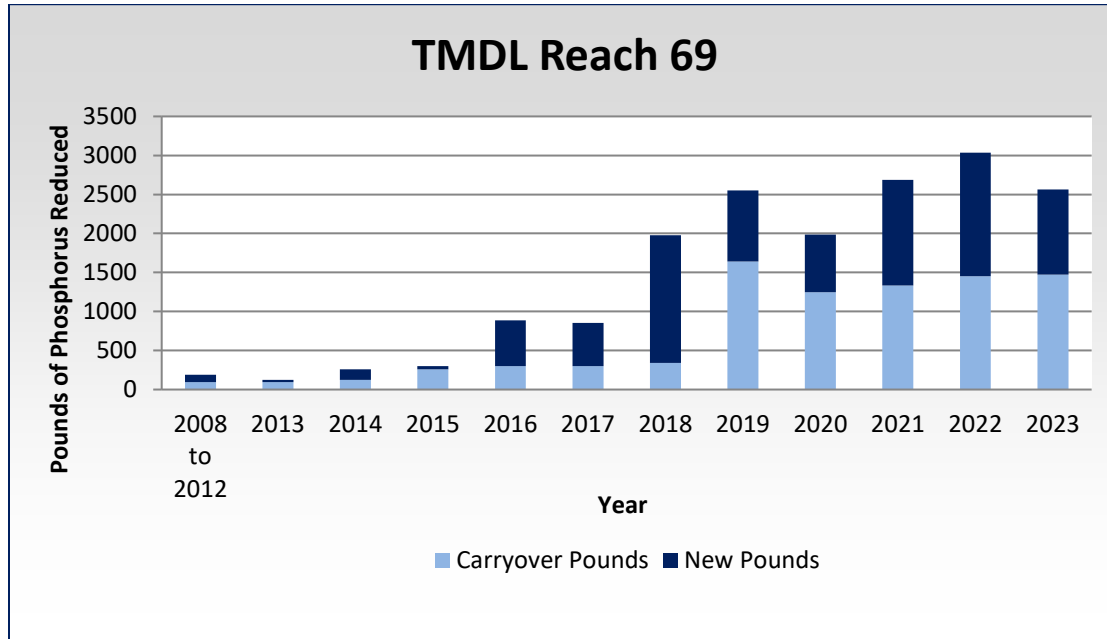
FIGURE 8.8.

TMDL Reach 69 new and carryover pounds of phosphorus reductions by year.

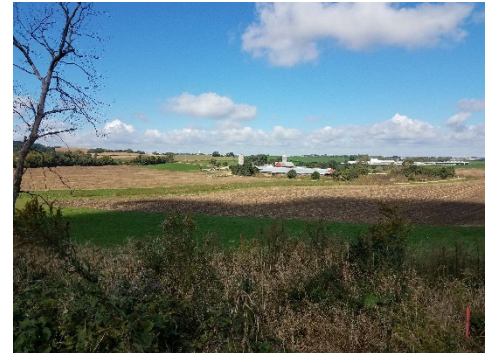
Pheasant Branch property before restoration

Dane County purchased a 160 acre property just north of the Pheasant Branch Conservancy in 2019. Since then, Dane County has implemented a four year restoration project that includes removing the barnyard, converted the cropped land to perennial vegetation, and constructing stormwater retention structures. Monitoring of runoff generation immediately before and after restoration by Dane County indicates that the restoration efforts have led to an order of magnitude decrease in runoff volume from the addition and its contributing watershed, bringing the empirical curve number down from 74 to 44. This decreased runoff volume is associated with an associated annual reduction in pollutant loading of approximately 5,400 pounds of sediment, 600 pounds of phosphorus, and 650 pounds of organic nitrogen.

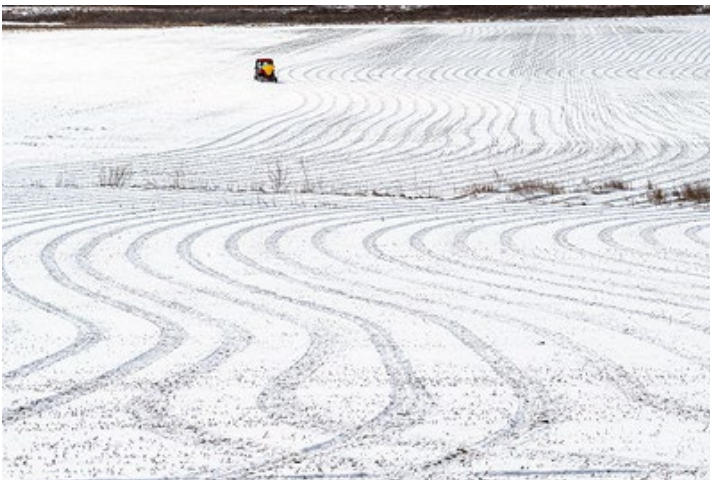
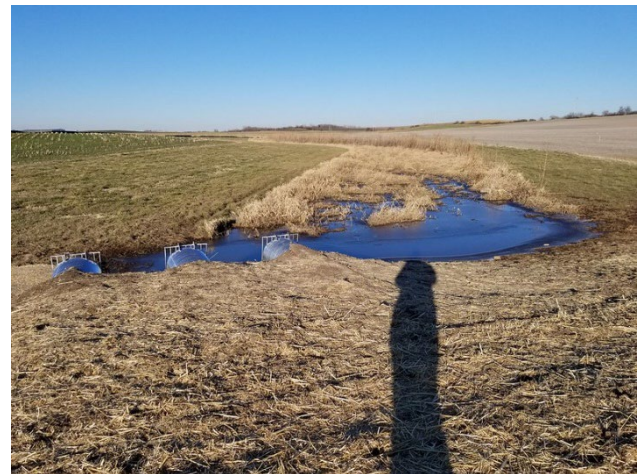
Left: Frost seeding prairie at Pheasant Branch Right: Sediment control basin constructed at Pheasant Branch
